APOLLO MOON LANDINGS

A Resource for Understanding the Hoax Claims

NATIONAL SPACE CENTRE

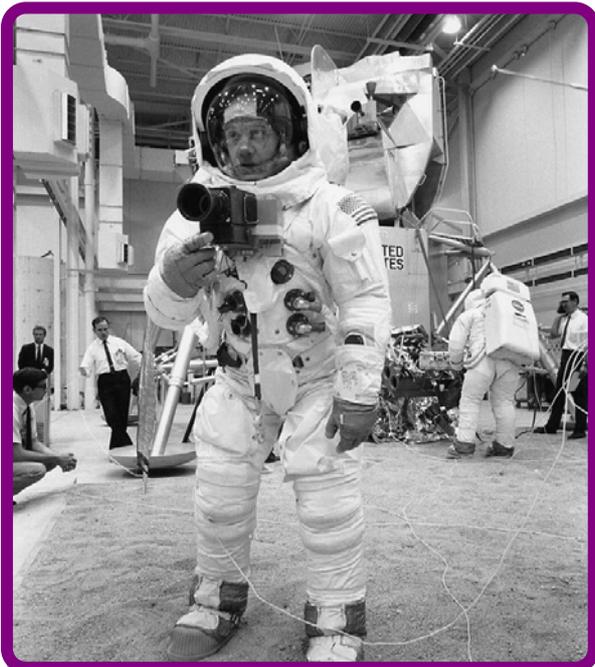
Buzz Aldrin, training with the chest-mounted Hasselblad camera before the Apollo 11 mission

Others have noted that crosshairs do not always appear level on the photographs. It is important to note that the camera was not mounted on a tripod, but attached to the astronaut's chest. As a result, one would expect some images to be slightly off horizontal. The images would go through processing that might include being realigned and cropped before being released.

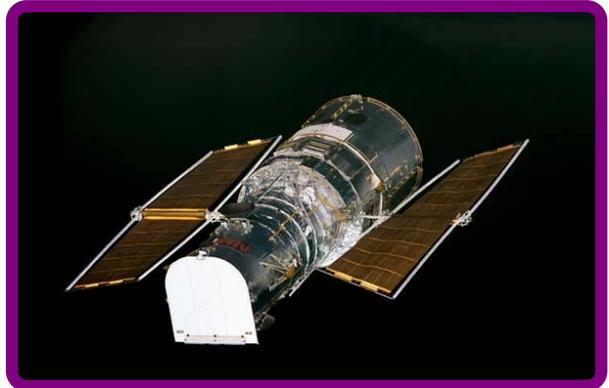
Notice the lack of stars in this image of Hubble Space Telescope captured by the STS-109 astronauts on 3 March 2002

A good comparison is to look at other images taken in space, such as those of the International Space Station, the Hubble Space Telescope, MIR, or the Space Shuttle. Again, none of these images show any stars in the background, because they were not the subject matter of the photos.

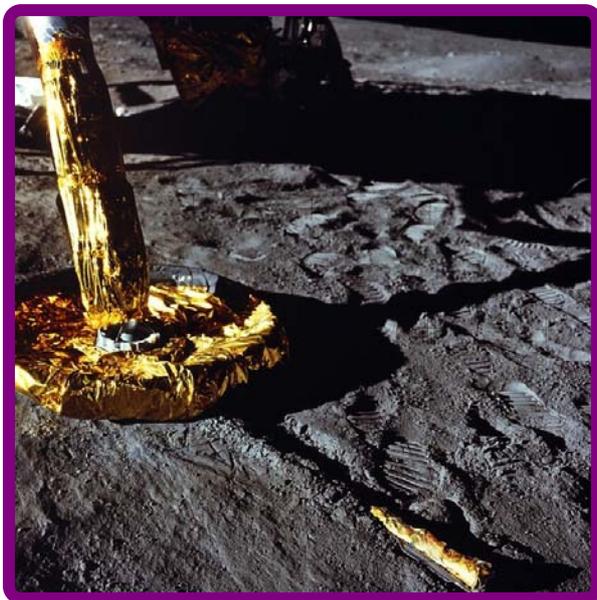
A footpad of an Apollo Lunar Module with no signs of dust on top

With regard to the absence of a blast crater, there are a couple of points to make. Firstly, the 4,500 kilograms of thrust were spread across the area of the engine nozzle, which was around 15,000 cm². This is equivalent to just 0.3 kilograms/cm².

Secondly, the engine would not have been firing on full thrust when the astronauts were coming in to land. As no exact landing site was known, the Lunar Module was actually flown in at an angle, thus allowing the pilot to see out of the LM's window to select the best available terrain to land on. The result of all this was a rather gentle thrust from the engine once the LM was finally straightened up and landed. The only dust disturbed was that which was in direct contact with the LM's exhaust. This dust fell quickly to the ground in the direction it was pushed - away from the immediate landing site.

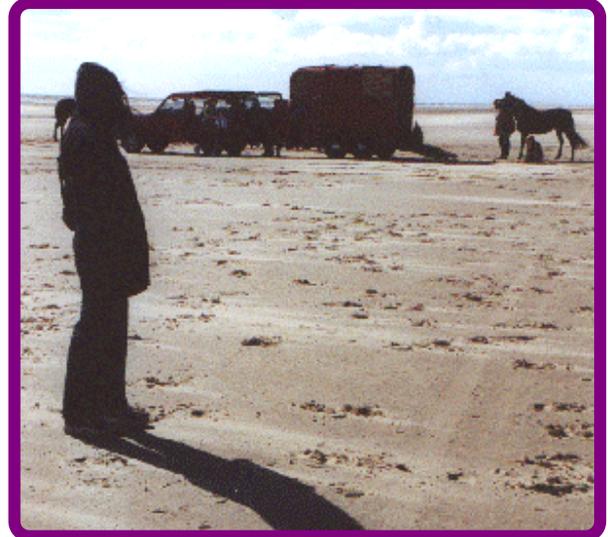
Shadows in a photograph on Earth showing the same alignment as those in the Apollo images

The directions and lengths of shadows are determined by a combination of the slope of the ground and differences in the depth of field of objects in the photographs. Just as parallel train lines, when represented in a 2D image, appear to meet a vanishing point in the distance, so shadows of objects at different distances will appear to radiate from a common point. Such variations in shadow length and apparent direction are common in many photographs taken on Earth.

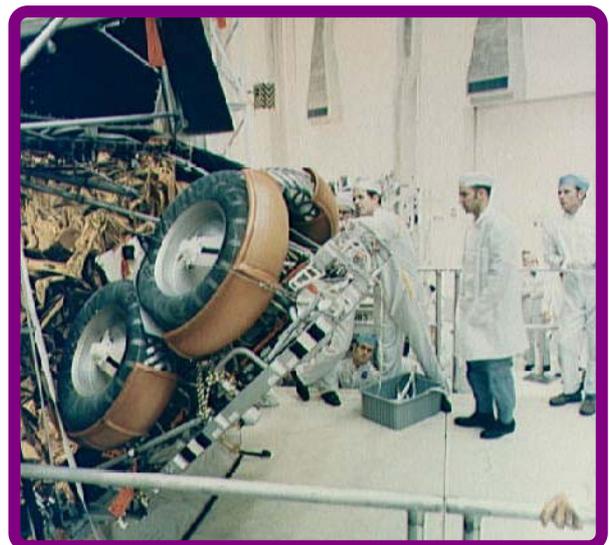
The Lunar Roving Vehicle folded and ready to be inserted into its wedge-shaped stowage compartment

An objection that is often raised by the conspiracy theorists is the size of the Lunar Roving Vehicle. The vehicle was 3.1 metres long by 2.3 metres wide, and 1.14 metres high. As the Lunar Module's descent stage was only 4.3 metres in diameter by 3.2 metres high, one might think this would not have left much room for the remaining equipment. However, the LRV was designed to fold up and fit into a wedge-shaped stowage compartment to the right of the ladder on the descent stage of the Lunar Module.

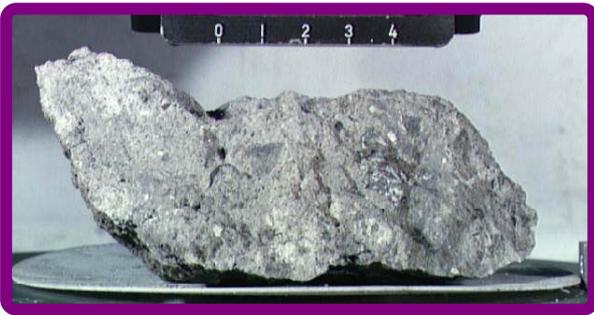
View of Apollo 17 lunar rock sample no. 76055

The samples of rock appear similar to terrestrial rocks on the surface, but chemically and structurally they are unlike anything on Earth. This is to be expected, since they formed in a markedly different environment.

To start, the surface of lunar material is covered in 'zap pits', microscopic evidence of bombardment by micrometeorites on the lunar surface. Such micrometeorites burn up in the Earth's atmosphere, but the Moon offers no such protection. Also, the minerals are said to be 'anhydrous', i.e. they contain no water or signs of water being involved in their formation. Coupled with evidence of long-term interaction with the Solar Wind, the experts agree, these rocks came from the Moon.
